**Flood Control Project Maintenance
Levee Inspections**

Maintenance Issue Types Only, Levee Inspection Report By Mile - Fall 2018

Levee District No. 0001 (Glenn County)

Waterway	Bank	Unit Miles	Inspection Start/End	Inspector
Unit No. 01 Sacramento River	Right	12.23	09/25/2018 09/25/2018	Bob Duffey

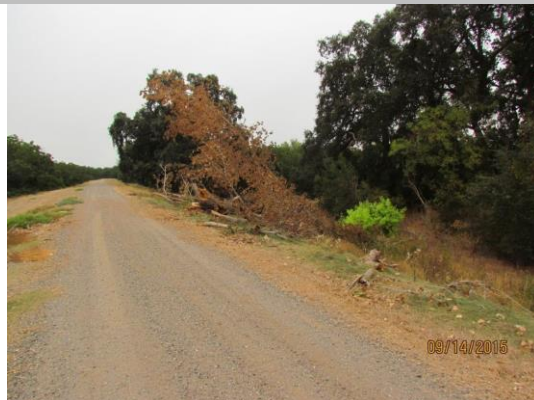
Photo 1 of 2 : FA_2018_LD0001G_432_41_20180905_00011.jpg

LM Start	0.25	Rating **	M	Issue No.	41
LM End	0.25	Issue Type +	Ma	Location *	WS
Category	Earthen Levee			GPS Latitude/Longitude	
				Start	End
Item	Encroachments			39.480769 °	39.480769 °
				-122.017301 °	-122.017301 °
DWR ID	DWR_LD0001G_01_f _ 2015_41				
Comment Code					
TR : Tree or limb					
Inspector Comment					
Remove tree from the waterside slope.

View of the tree on the waterside slope.

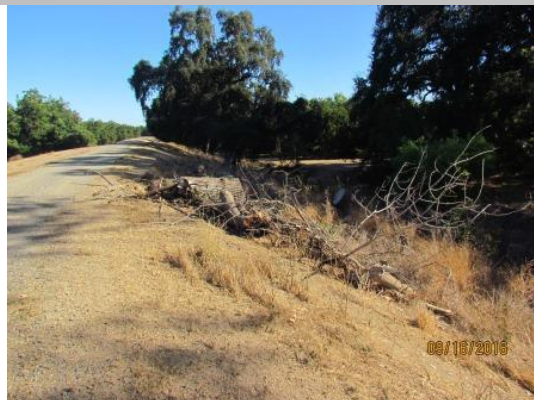
Photo 2 of 2 : FA_2018_LD0001G_432_41_20180905_00012.jpg

View of the fallen tree on the waterside slope looking upstream.

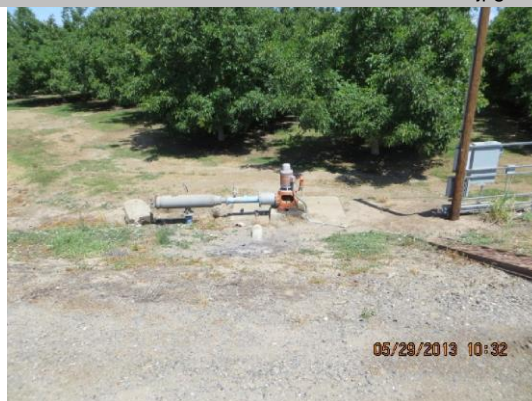
Photo 1 of 3 : UCIP_FA_2018_14332_23582.jpg

LM Start	2.22	Rating **	M	Issue No.	402	
LM End	2.22	Issue Type +	Ma	Location *		
Category	Supplemental			GPS Latitude/Longitude		
				Start	End	
Item	DWR UCIP LMA Responsibility			39.501690 °	39.501690 °	
				-122.006099 °	-122.006099 °	
DWR ID	22944					
Comment Code						
Inspector Comment						
FS_ID:14332 DS_ID:22944 EP_NO: N/A Repair Type: Non-Urgent Crossing Status: Found UCIP Comments: Appears abandoned and should be done so properly. FIELD_STRUCT_DESC: *ABANDONED* 8-inch drainage pipe of an unknown material sleeved through a 12-inch pipe of an unknown material through the levee, 9.5 feet below the crown. Flap gate located on the waterside (WS). Pipe open on the landside (LS). [Additional Reference(s): USACE Sacramento O&M Manual 140, May 1960, (HLM 2.27)]. FS Date: 5/29/2013

Pump at location of pipe on LS toe.

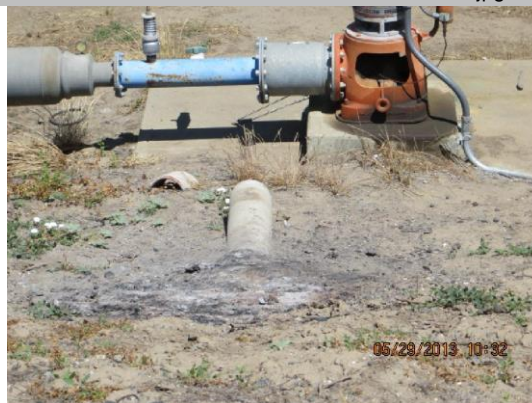
Photo 2 of 3 : UCIP_FA_2018_14332_23581.jpg

Pipe next to pump at LS toe.

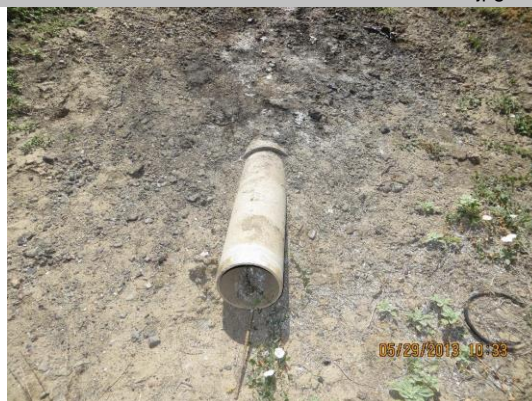
Photo 3 of 3 : UCIP_FA_2018_14332_23580.jpg

LM Start	2.22	Rating **	M	Issue No.	402 (cont)	
LM End	2.22	Issue Type +	Ma	Location *		
Category	Supplemental			GPS Latitude/Longitude		
				Start	End	
Item	DWR UCIP LMA Responsibility			39.501690 °	39.501690 °	
				-122.006099 °	-122.006099 °	
DWR ID	22944					
Comment Code						
Inspector Comment						
FS_ID:14332 DS_ID:22944 EP_NO: N/A Repair Type: Non-Urgent Crossing Status: Found UCIP Comments: Appears abandoned and should be done so properly. FIELD_STRUCT_DESC: *ABANDONED* 8-inch drainage pipe of an unknown material sleeved through a 12-inch pipe of an unknown material through the levee, 9.5 feet below the crown. Flap gate located on the waterside (WS). Pipe open on the landside (LS). [Additional Reference(s): USACE Sacramento O&M Manual 140, May 1960, (HLM 2.27)]. FS Date: 5/29/2013

8-inch pipe sleeved through a 12-inch concrete pipe.

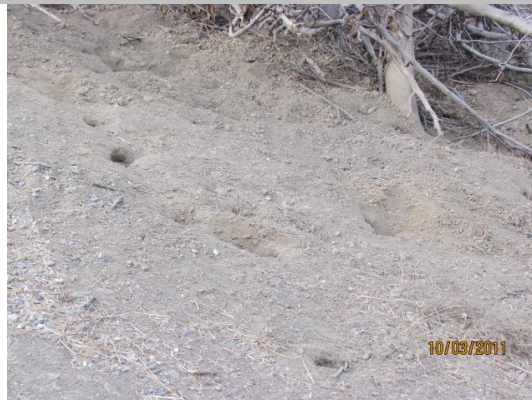
Photo 1 of 1 : FA_2018_LD0001G_432_395_20180905_00034.jpg

LM Start	3.88	Rating **	A/W	Issue No.	395
LM End	3.88	Issue Type +	Ma	Location *	LS
Category	Earthen Levee			GPS Latitude/Longitude	
				Start	End
Item	Animal Control			39.523845 °	39.523845 °
				-122.010745 °	-122.010745 °
DWR ID	DWR_LD0001G_01_s_2012_395				
Comment Code					
A3 : No rodents visible, but rodent burrows visible; need to backfill and compact or grout burrows.					
Inspector Comment					
Unable to see the rodent holes because of the prunings pile. Backfill and compact the rodent holes on the landside slope.

View of the rodent holes along the LS toe.

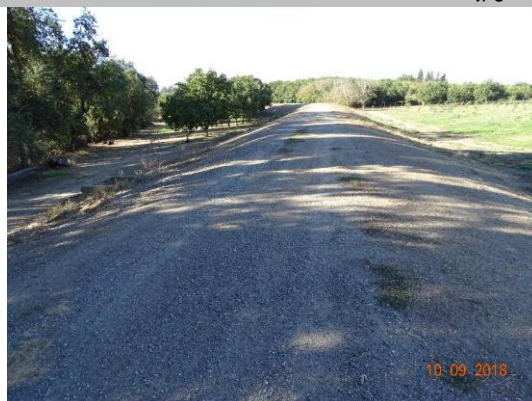
Photo 1 of 3 : UCIP_FA_2018_53006_78123.jpg

View of levee crown at the crossing.

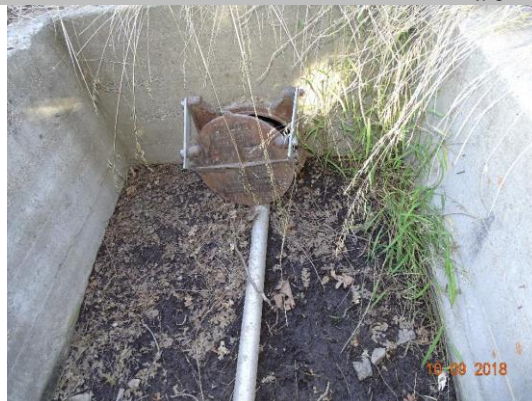
Photo 2 of 3 : UCIP_FA_2018_53006_78124.jpg

(O. Yakimov - DWR)12/21/2016 Flap gate on WS does not appear to be broken however, flap gate does not fully close due to a 3-inch aluminum pipe sleeve through larger pipe. Need to remove 3-inch pipe in order to have WS flap gate close and to be compliant with Title 23.

(O. Magana - DWR UCIP)05/29/2013 Broken flap gate and Concrete headwall on LS toe possibly tilting. Also a 3-inch aluminum irrigation line through the pipe. (W. Wylie - DWR UCIP)

3-inch pipe obstructs flap gate from complete closing.

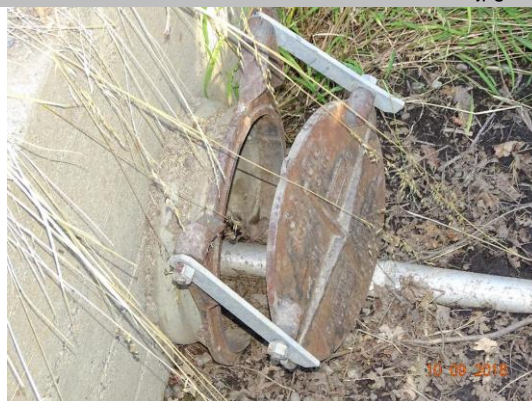
Photo 3 of 3 : UCIP_FA_2018_53006_78125.jpg

(O.Yakimov - DWR)12/21/2016 Flap gate on WS does not appear to be broken however, flap gate does not fully close due to a 3-inch aluminum pipe sleeve through larger pipe. Need to remove 3-inch pipe in order to have WS flap gate close and to be compliant with Title 23.

(O. Magana - DWR UCIP)05/29/2013 Broken flap gate and Concrete headwall on LS toe possibly tilting. Also a 3-inch alluminum irrigation line through the pipe. (W. Wylie - DWR UCIP)

3-inch pipe obstructs flap gate from complete closing.

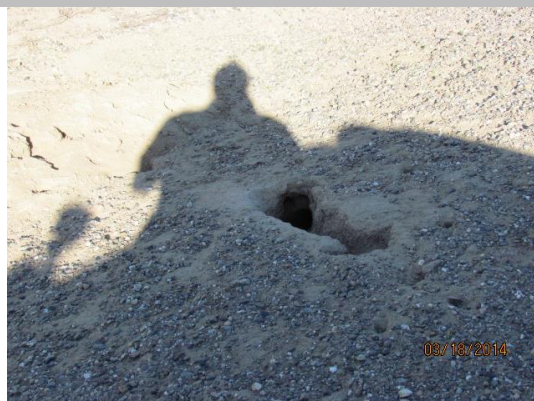
Photo 1 of 1 : FA_2018_LD0001G_432_47_20180905_00014.jpg

View of the rodent activity along the LS slope.

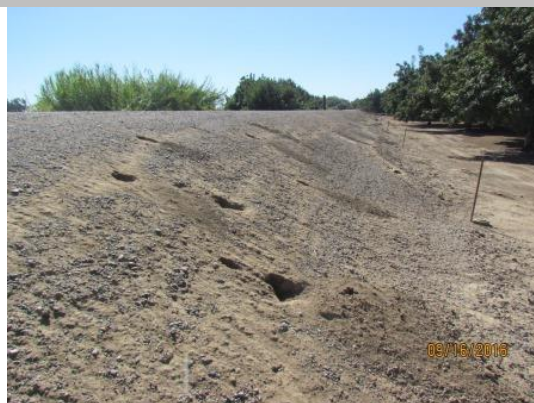
Photo 1 of 1 : FA_2018_LD0001G_432_76_20180905_00030.jpg

LM Start	6.24	Rating **	M	Issue No.	76
LM End	6.24	Issue Type +	Ma	Location *	LS
Category	Earthen Levee			GPS Latitude/Longitude	
				Start	End
Item	Animal Control			39.550725 °	39.550725 °
				-122.002370 °	-122.002370 °
DWR ID	DWR_LD0001G_01_f _ 2016_76				
Comment Code					
A3 : No rodents visible, but rodent burrows visible; need to backfill and compact or grout burrows.					
Inspector Comment

View of the rodent holes along the landside slope.

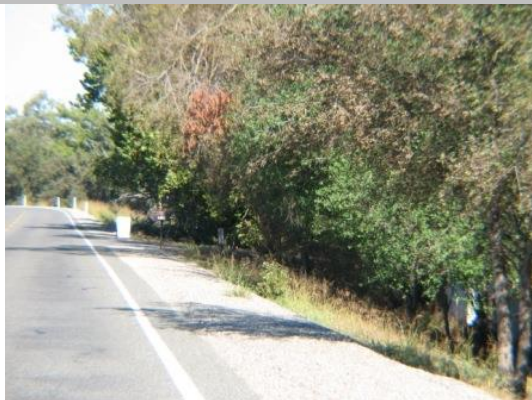
Photo 1 of 1 : FA_2018_LD0001G_432_20_20180905_00008.jpg

View of the trees and vegetation along the waterside slope of the levee.

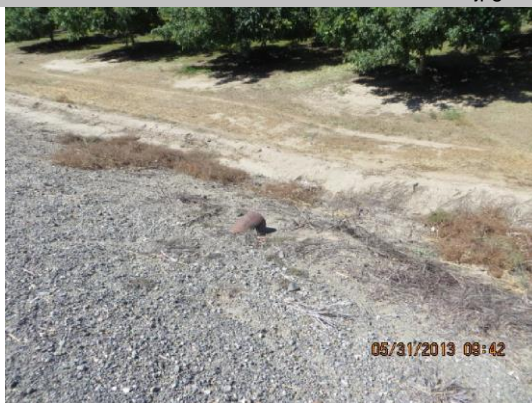
Photo 1 of 3 : UCIP_FA_2018_53341_23668.jpg

Comment Code						
Inspector Comment						
FS_ID:53341 DS_ID:22918 EP_NO: 9563 Repair Type: Non-Urgent Crossing Status: Found UCIP Comments: 10/9/2018 Pipe is open on both ends and damaged on WS. Recommended grouting in place. Crossing downgraded to "Non-Urgent" due to pipe location above floodplain. (O.Yakimov - DWR)12/21/2016 same as last inspection crossing is opened on both ends and damaged on WS slope is visible. According to LMA representative, Nick Henning, pipe appears to be abandoned. (O. Magana - DWR UCIP)05/31/2013 Pipe open on both ends and damaged on WS slope. Pipe should be abandoned properly if appropriate. (W. Wylie - DWR UCIP) FIELD_STRUCT_DESC: *ABANDONED* 12-inch steel drainage pipe through levee, 5 feet below crown. Pipe open on both waterside (WS) and landside (LS) ends. One corrugated metal cutoff wall. (12-inch pipe [HLM 8.6] authorized under Automatic Board Order (ABO) No. 9563, 1974 - County of Glenn). [Additional Reference(s): DWR Levee Log, 1992. USACE Sacramento O&M Manual Unit 140, May 1960, (HLM 8.60)]. FS Date: 10/9/2018 3:57:00 PM

Pipe on LS slope.

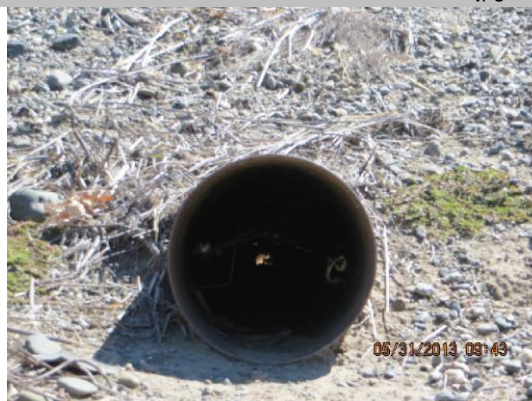
Photo 2 of 3 : UCIP_FA_2018_53341_23667.jpg

Comment Code						
Inspector Comment						
FS_ID:53341 DS_ID:22918 EP_NO: 9563 Repair Type: Non-Urgent Crossing Status: Found UCIP Comments: 10/9/2018 Pipe is open on both ends and damaged on WS. Recommended grouting in place. Crossing downgraded to "Non-Urgent" due to pipe location above floodplain. (O.Yakimov - DWR)12/21/2016 same as last inspection crossing is opened on both ends and damaged on WS slope is visible. According to LMA representative, Nick Henning, pipe appears to be abandoned. (O. Magana - DWR UCIP)05/31/2013 Pipe open on both ends and damaged on WS slope. Pipe should be abandoned properly if appropriate. (W. Wylie - DWR UCIP) FIELD_STRUCT_DESC: *ABANDONED* 12-inch steel drainage pipe through levee, 5 feet below crown. Pipe open on both waterside (WS) and landside (LS) ends. One corrugated metal cutoff wall. (12-inch pipe [HLM 8.6] authorized under Automatic Board Order (ABO) No. 9563, 1974 - County of Glenn). [Additional Reference(s): DWR Levee Log, 1992. USACE Sacramento O&M Manual Unit 140, May 1960, (HLM 8.60)]. FS Date: 10/9/2018 3:57:00 PM

Pipe on LS slope.

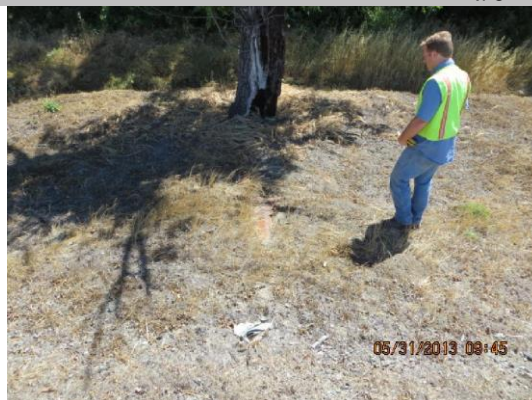
Photo 3 of 3 : UCIP_FA_2018_53341_23666.jpg

Pipe on WS slope.

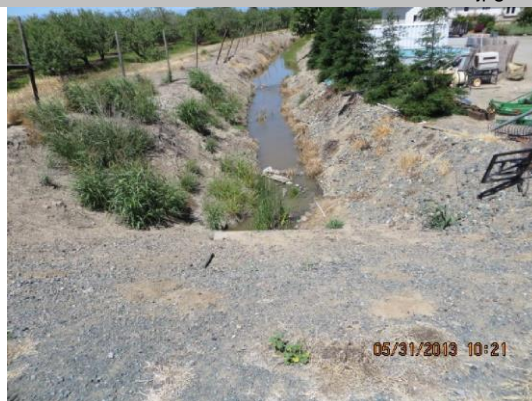
Photo 1 of 3 : UCIP_FA_2018_14389_23686.jpg

Comment Code					
Inspector Comment					
FS_ID:14389 DS_ID:22920 EP_NO: 9560 Repair Type: Non-Urgent Crossing Status: Found UCIP Comments: Heavy rust along springline of pipe. Pipe has slight deformation at centerline of levee, not noticable on crown. FIELD_STRUCT_DESC: 72-inch corrugated metal drainage pipe through the levee, 15 feet below the crown. Flap gate located on the waterside (WS) end. Slide gate in 8-inch corrugated metal riser unit on the WS slope. Concrete headwalls on both ends. Two corrugated metal cutoff walls. (72-inch pipe [HLM 9.64]authorized under Automatic Board Order (ABO) issued as Permit No. 9560, 1974 - John and Lena Friesen). [Additional Reference(s): DWR Levee Log, 1992. USACE Sacramento O&M Manual 140, May 1960, (HLM 9.64)]. FS Date: 5/31/2013

Pipe and headwall at LS toe.

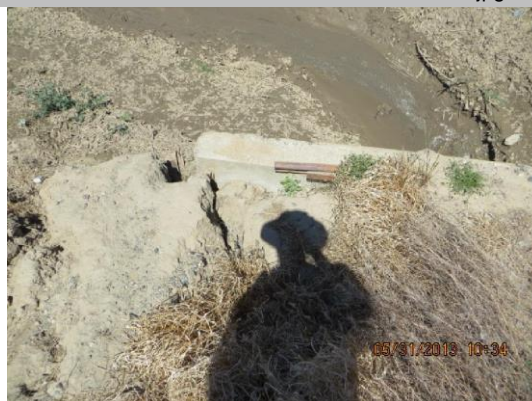
Photo 3 of 3 : UCIP_FA_2018_14390_23688.jpg

Erosion around headwall at LS toe.

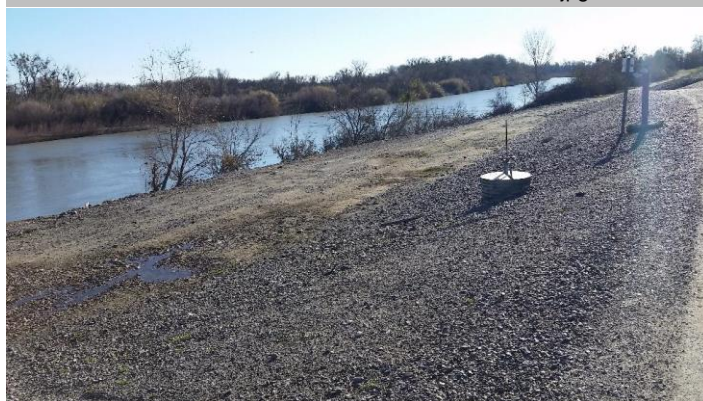
Photo 1 of 3 : UCIP_FA_2018_53340_76411.jpg

UCIP Comments: 10/9/2018 Large rock at the bottom of CMP riser obstructs slide gate from completely closing. Pipe is rusted through at WS end. Recommend internal inspection to determine condition of pipe through levee, and to clean the inside of CMP riser for proper slide gate function. (O.Yakimov - DWR)12/21/2016 same as last inspection flap gate disabled in open position. Surface erosion observed on LS slope. Recommend repair on WS flap gate to be able to close flap gate. (O. Magana - DWR UCIP)05/31/2013 Flap gate dissabled in open position. Pipe rusted through at WS toe upstream of Flapgate. (W. Wylie - DWR UCIP)

View of WS.

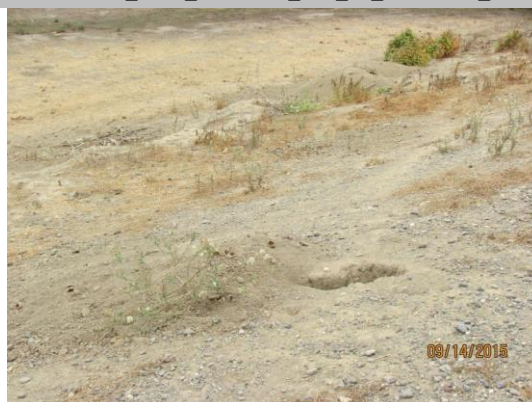
Photo 1 of 1 : FA_2018_LD0001G_432_66_20180905_00021.jpg

LM Start	11.10	Rating **	M	Issue No.	66
LM End	11.18	Issue Type +	Ma	Location *	WS
Category	Earthen Levee			GPS Latitude/Longitude	
				Start	End
Item	Animal Control			39.617252 °	39.618192 °
				-121.994605 °	-121.995609 °
DWR ID	DWR_LD0001G_01_f_2015_66				
Comment Code					
A3 : No rodents visible, but rodent burrows visible; need to backfill and compact or grout burrows.					
Inspector Comment					
Repair the rodent holes along the waterside slope.

View of the rodent holes along the waterside slope.

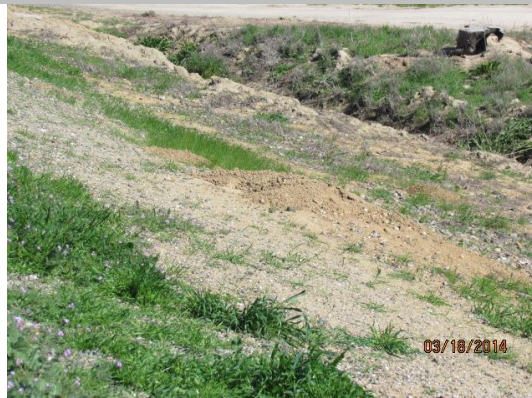
Photo 1 of 1 : FA_2018_LD0001G_432_48_20180905_00015.jpg

View of the rodent activity along the waterside slope.

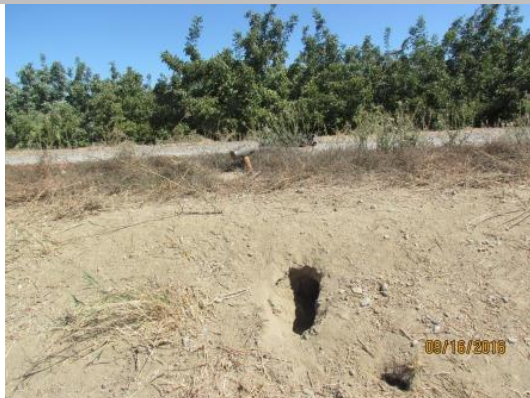
Photo 1 of 2 : FA_2018_LD0001G_432_79_20180905_00032.jpg

View of the rodent holes along the landside slope with large hammer sitting in the hole.

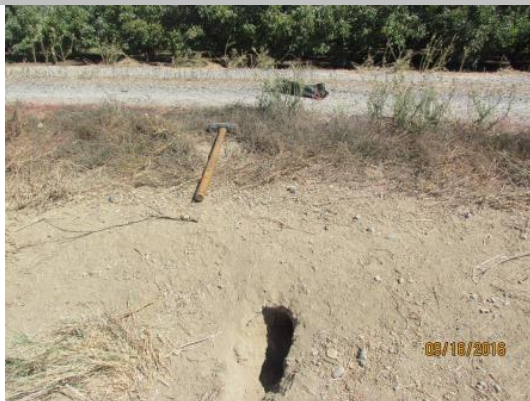
Photo 2 of 2 : FA_2018_LD0001G_432_79_20180905_00033.jpg

Another view of the rodent holes along the landside slope with a large hammer sitting next to the hole.

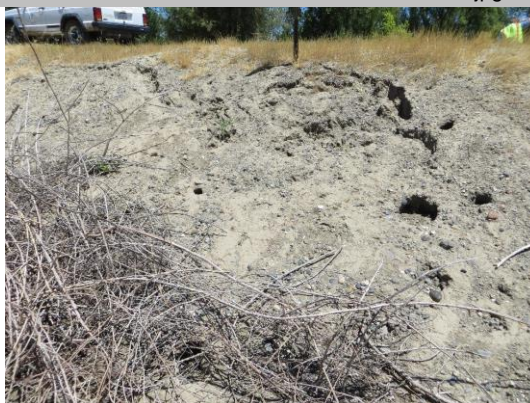
Photo 3 of 3 : UCIP_FA_2018_14567_24015.jpg

Comment Code					
Inspector Comment					
FS_ID:14567 DS_ID:22927 EP_NO: 9554 Repair Type: Non-Urgent Crossing Status: Found UCIP Comments: Erosion and sloughing on LS slope possibly due to rodent activity in area. FIELD_STRUCT_DESC: 24-inch corrugated metal drainage pipe through the levee, 11 feet below the crown. Slide gate in 36-inch corrugated metal riser unit on the waterside (WS) slope. 48-inch concrete standpipe on the landside (LS) toe. Two corrugated metal cutoff walls. (24-inch pipe [HLM 11.93] authorized under Automatic Board Order (ABO) issued as Permit No. 9554, 1974 - Thomas H. Reed). [Additional Reference(s): DWR Levee Log, 1992. USACE Sacramento O&M Manual 140, May 1960, (HLM 11.93)]. FS Date: 5/31/2013

Erosion and sloughing on LS slope possibly due to rodent activity.
